# DON'T JUST TAKE OUR WORD FOR IT!

Here are sawline summary reports taken independently on production runs by a major western mill: results that convinced them to switch to Cougar Vari-Pitch and then to COUGAR XX Tension Stabilizing.

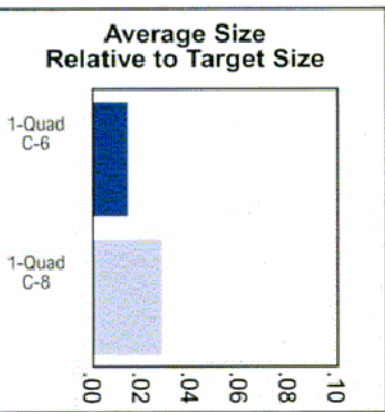
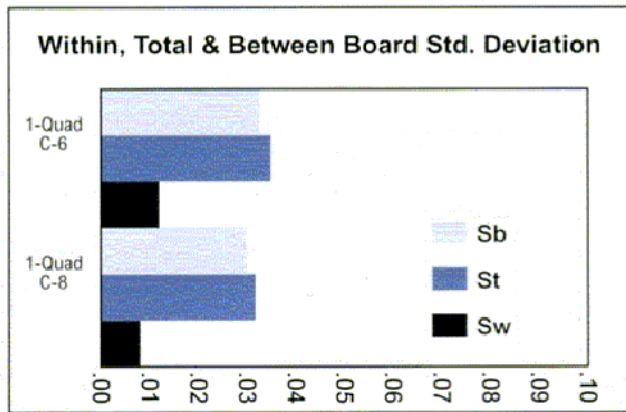
## COUGAR STANDARD TOOTH/STD.

Saw Line	Trgt	Avg	Sw Obj	Sw*	Sb Obj	Sb	St Obj	St	Avg
1-Quad C6	5.813	5.824	0.030	0.012	0.030	0.031	0.040	0.033	11
1-Quad C8	7.750	7.772	0.030	0.010	0.030	0.028	0.040	0.030	11

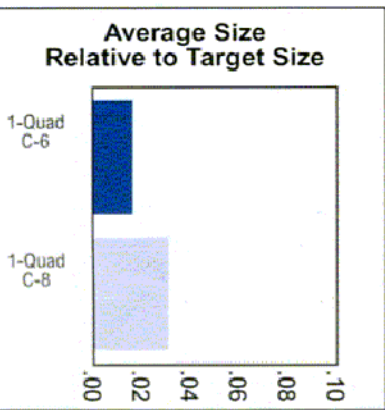
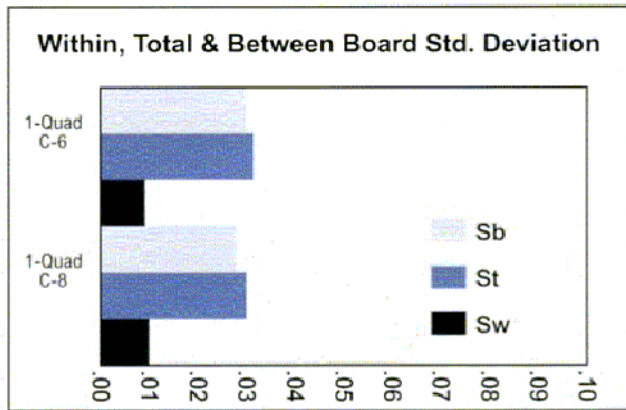
## COUGAR VARI-PITCH/STD. PLATE

Saw Line	Trgt	Avg	Sw Obj	Sw*	Sb Obj	Sb	St Obj	St	Avg
1-Quad C6	5.813	5.824	0.030	0.007	0.030	0.028	0.040	0.030	9
1-Quad C8	7.750	7.776	0.030	0.008	0.030	0.027	0.040	0.029	9

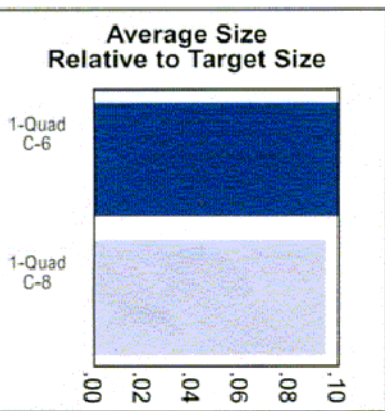
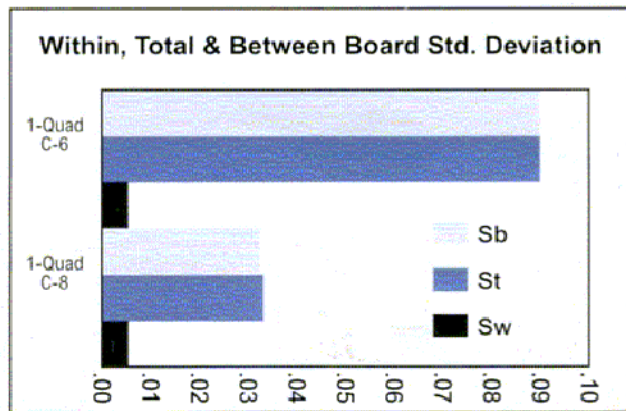
## COUGAR XX VARI-PITCH TENSION STABILIZED PLATE

Saw Line	Trgt	Avg	Sw Obj	Sw*	Sb Obj	Sb†	St Obj	St	Avg
1-Quad C6	5.813	5.977	0.030	0.004	0.030	0.090	0.040	0.090	7
1-Quad C8	7.750	7.843	0.030	0.004	0.030	0.031	0.040	0.032	7

† Temposonic networks acting up.
